## DYLYN®/DLC for plastic injection

### ■ Mobile phones

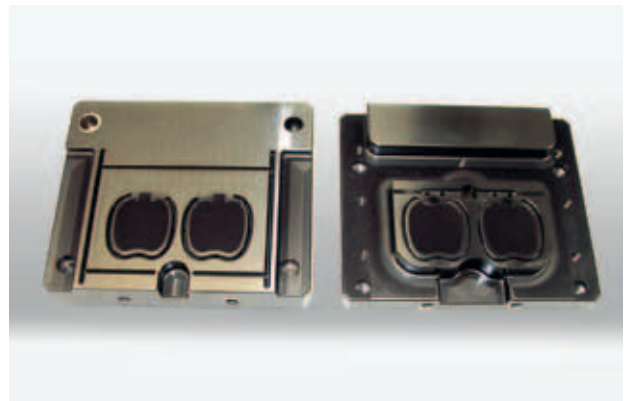
#### Mould inserts for sight glasses of mobile phones

**Before: Uncoated**

- Build-up of residue
- When removing residues, parts get scratched
- Corrosion
- Carbide erodin

**Now: DYLYN® 180**

All 4 demands solved with ONE coating!

- No change of transparency of the product
- No post-polish necessary, because our coating does not change the roughness

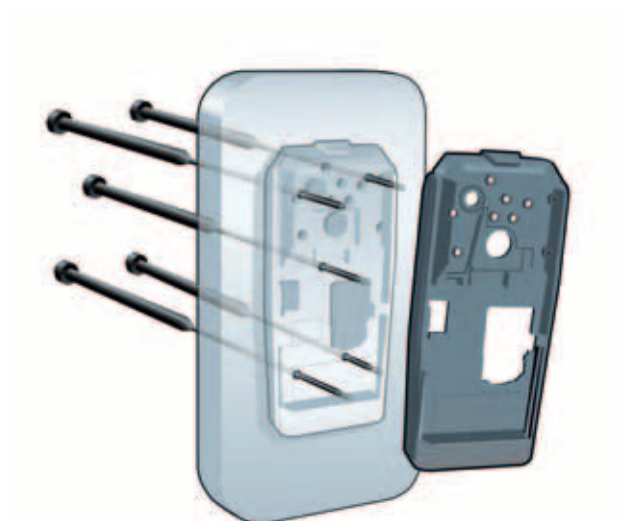
#### Ejector pins for production of mobile phone front covers requiring secondary operation to apply EMI shielding on back side of cover

**Before: WCC coating with grease**

- Due to lubricant residue around the impression of the ejector pins: 60 % scrap
- Maintenance mainly because of resinated grease:
  - Cleaning & new grease
  - After every 35,000 shots
- Frequent production stops due to galling of the ejector pins

**Now: DYLYN®/DLC without grease:**

- Yield ratio: 99 %
- Maintenance:
  - Reduced to wipe-off & control
  - Only after every 150,000 shots
- Last documented wear control after 1.35 million shots without visible wear
- Production stops due to galling reduced to < 0.3 %
