DYLYN®/DLC for plastic injection

■ Caps & Closures

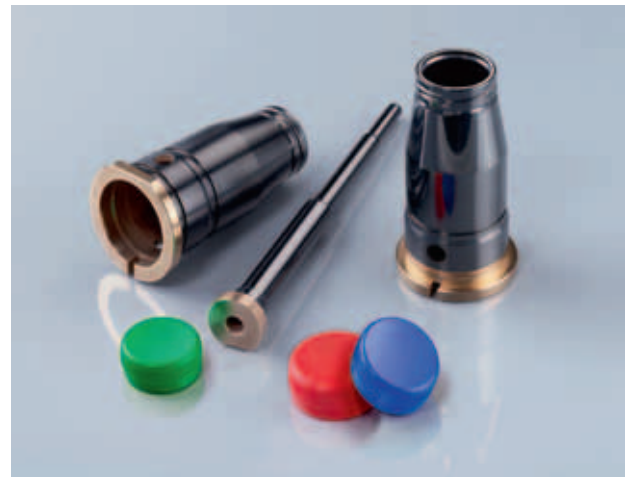
Thread cores made of CuBe-material for caps of beverage bottles

Before: WCC coating with grease

- Poor wear protection (galling)
- Coating adhesion problems due to oxidation of Cu-based material
- May need post polishing to make coating work
- Black particle contamination may occur during initial start up

Now: DLC/DYLYN® 360 (A) without grease

- After more than a year and over 9 Mio. shots – still no visible wear!!
- No loss of coating due to oxidation protection
- No post polishing necessary
- No break in period – no black particle contamination

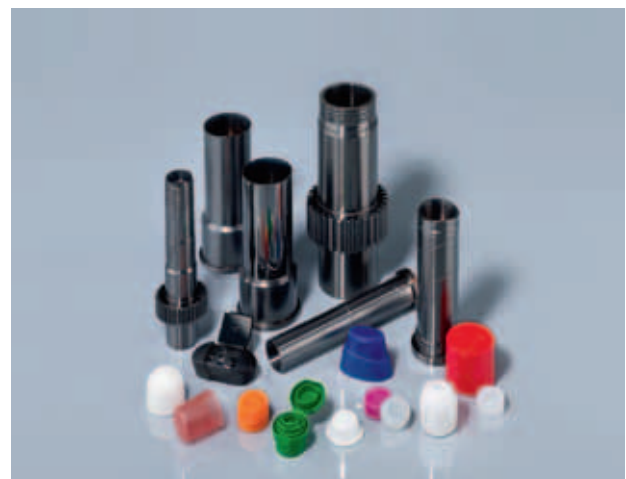
Ejector sleeves for food packaging closures

Before: WCC coating with grease

- Not meeting life goals
- Black particle contamination may occur during initial start up

Now: DYLYN®/DLC without grease

- Still no wear after 4 Mio. shots
- No break in period – no black particle contamination
