Dylyn[®]/DLC for plastic injection

■ Mobile phones

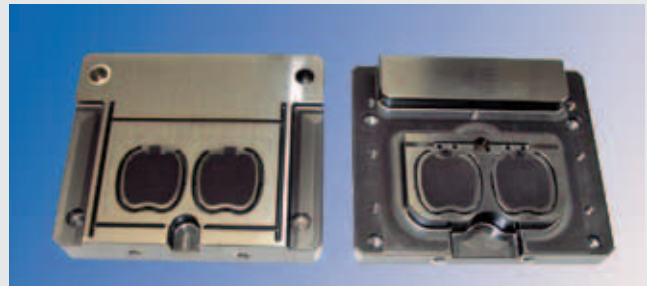
Mold inserts

for sight glasses of mobile phones

Before:

Uncoated – no grease

- Build-up of residue
- When removing residues, parts get scratched
- Corrosion
- Carbide erosion

After:

Dylyn[®] 180

- All 4 demands solved with ONE coating!
- No change of transparency of the product
- No post-polish necessary, cause our coating doesn't change the roughness

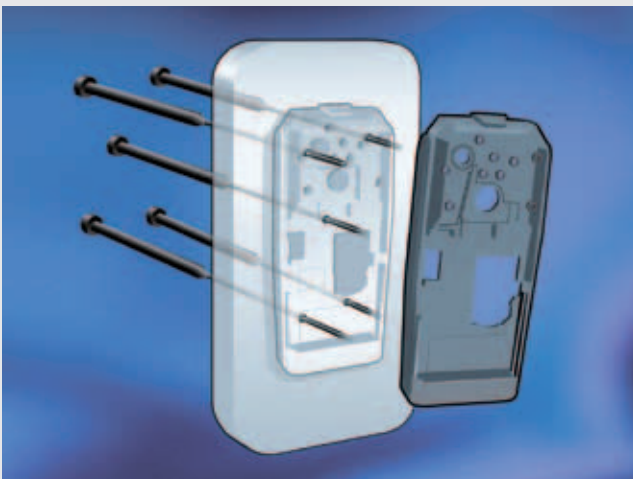
Ejector pins

for production of mobile phone front covers requiring secondary operation to apply EMI-shielding on back side of cover

Before:

WCC-coating with grease

- Due to lubricant residue around the impression of the ejector pins: 60% scrap
- Maintenance mainly because of resinated grease:
 - Cleaning & new grease
 - After every 35000 shots
- Frequent production stops due to galling of the ejector pins

After:

Dylyn[®]/DLC without grease

- Yield ratio: 99%
- Maintenance:
 - Reduced to wipe-off & control
 - Only after every 150.000 shots
- Last documented wear control after 1.35 million shots without visible wear
- Production stops due to galling reduced to < 0.3%
